EAST BRANCH
RESERVOIR DAM
NJ 00373

PHASE 1 INSPECTION REPORT
NATIONAL DAM SAFETY PROGRAM

East Branch Reservoir Dam (NJ 00373)
Raritan River Basin, East Branch,
Somerset County, New Jersey.
Phase 1 Inspection Report.

11
August 1979

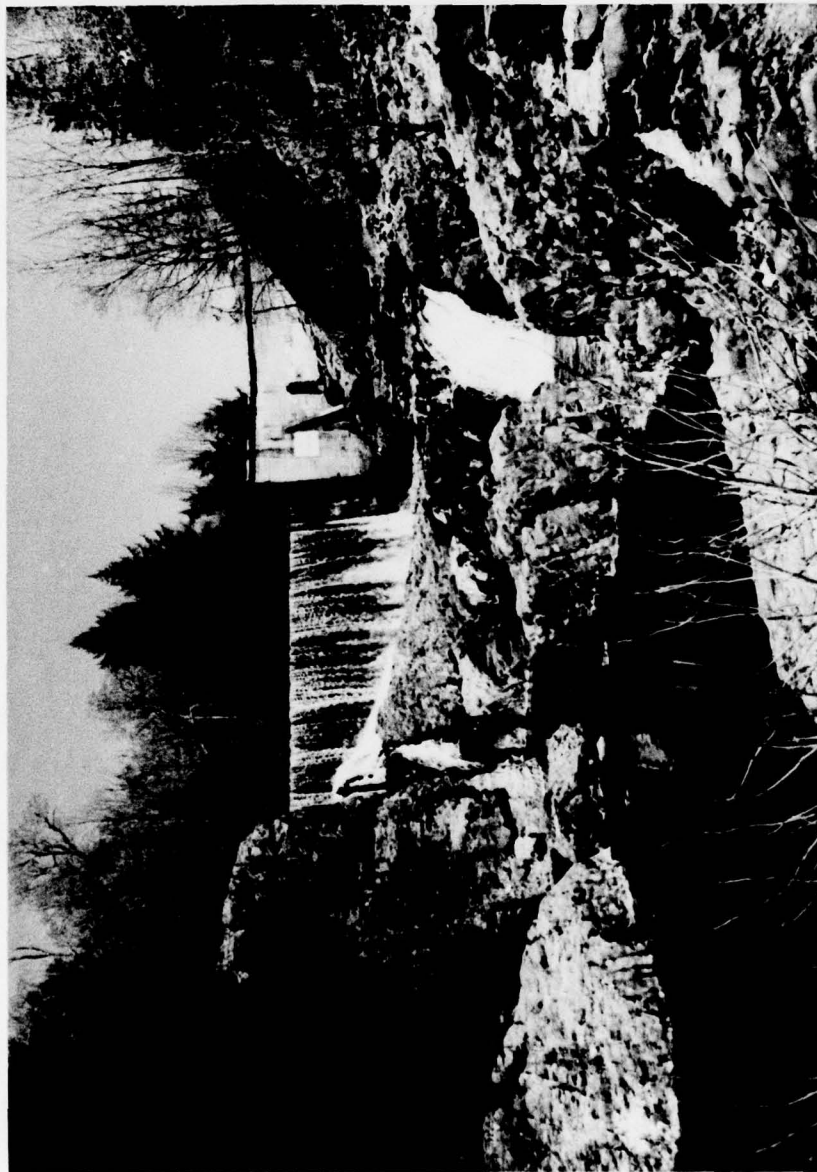
East Branch Reservoir Dam
Overall view of dam from downstream.

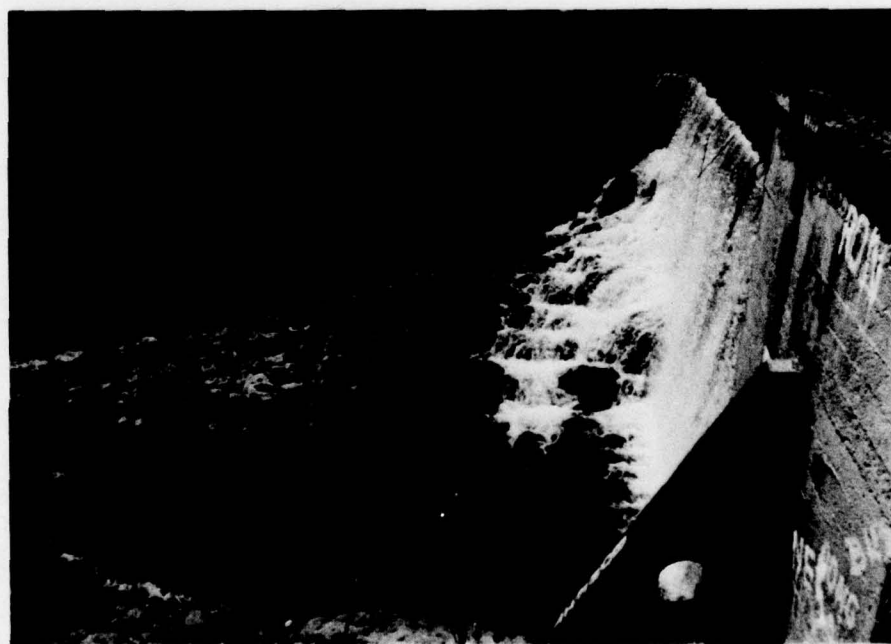
The condition of the spillway is poor. The concrete surface is spalled, revealing reinforcing steel. The spillway, however, shows no signs of movement and is in good alignment.

Photo No. 2 - View of spillway crest from the left bank.

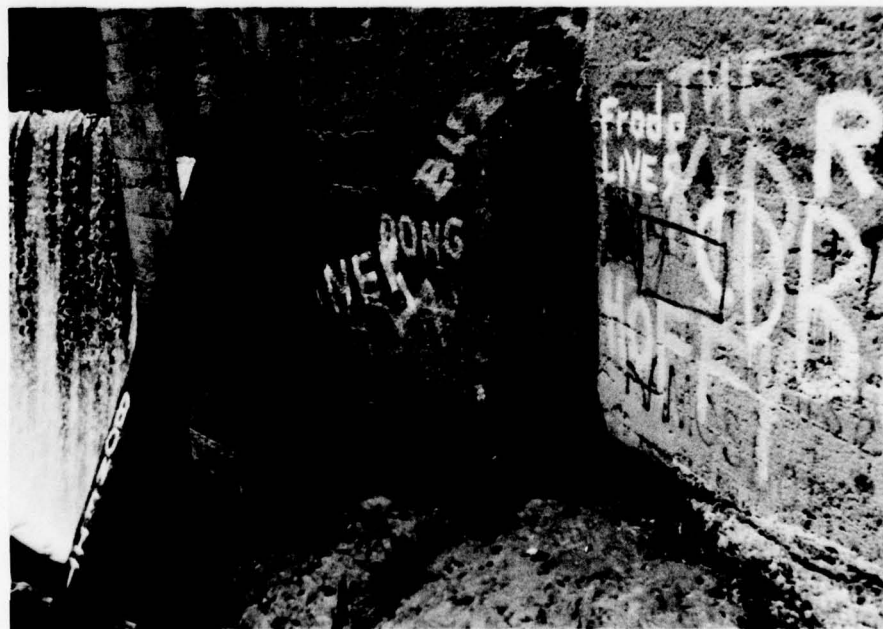
Photo No. 4 - View of inspection tunnel entrance and buttress. Note seepage at the base of the structure, and deteriorated concrete.
